Arborist Report

Inventory and Assessment of Trees Associated to Development
at 19476 Hammond Road, Pitt Meadows

August 30, 2021

Hanah Dhanani, Bachelor of Urban Forestry
ISA Certified Arborist PN 9275A

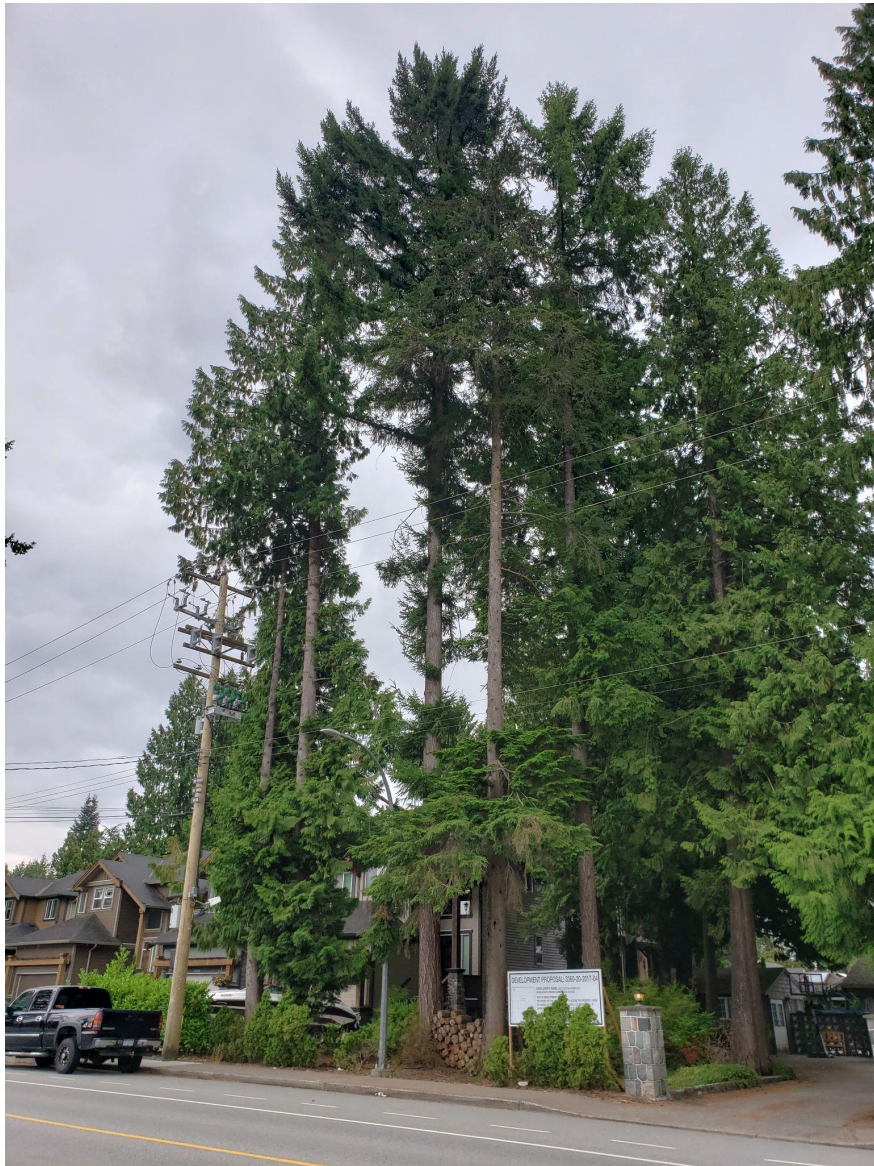
IMAGE 1- Trees on the north-west corner of the property.

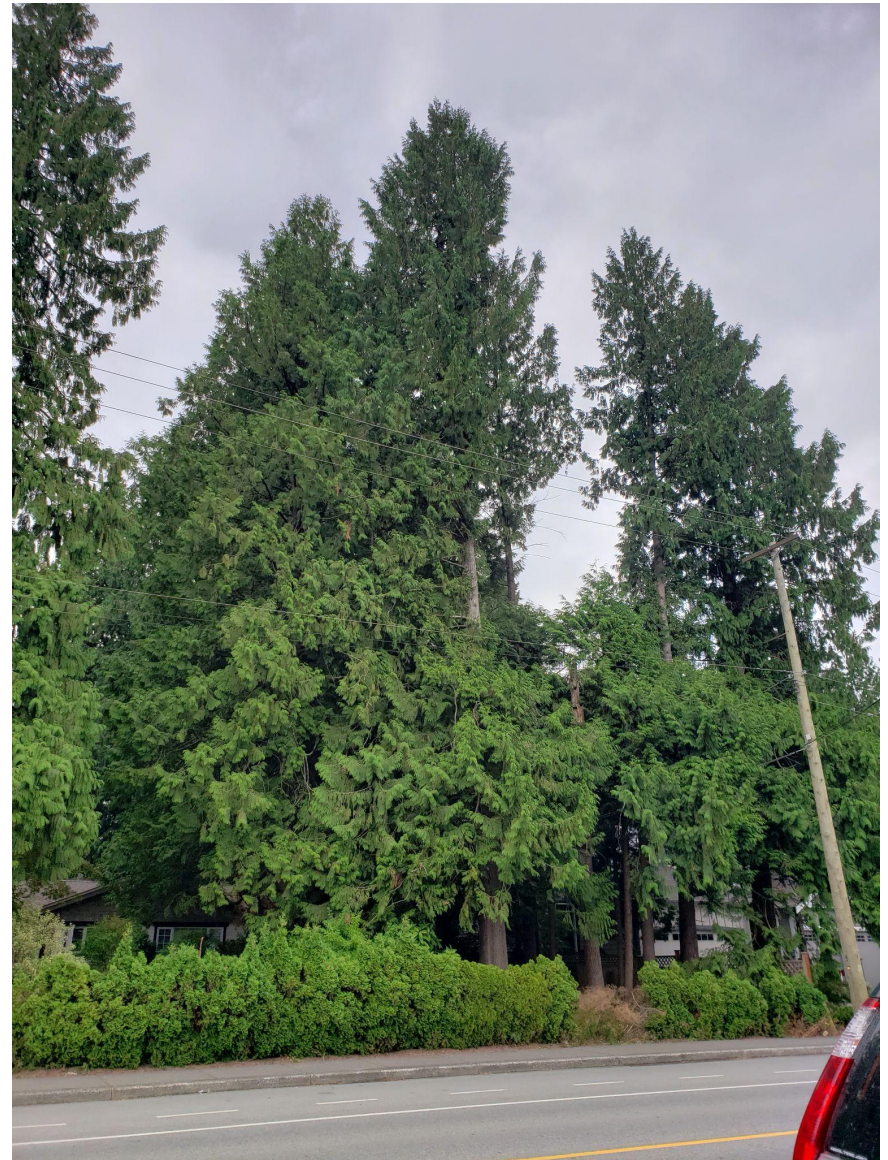
IMAGE 2- Trees on the north-east corner of the property.

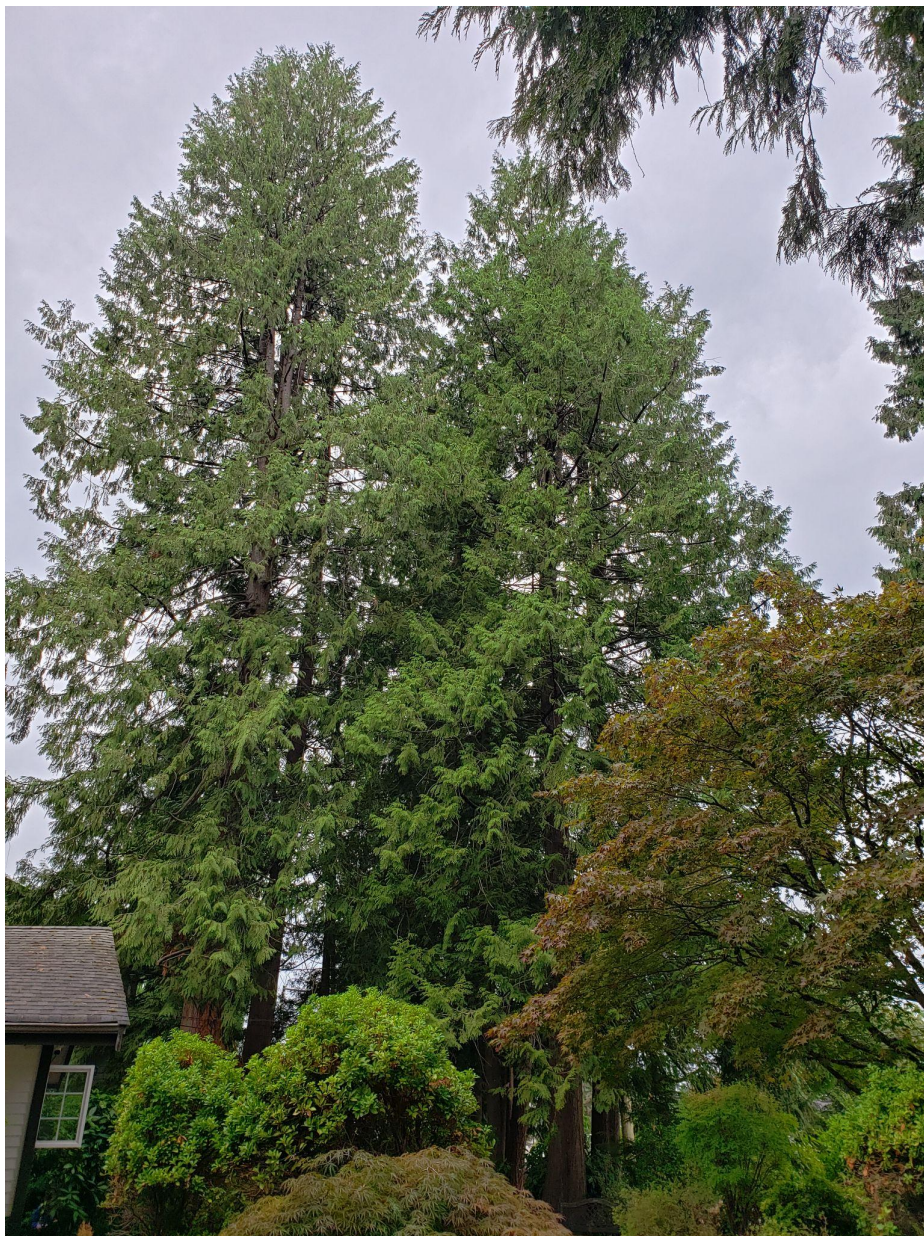
IMAGE 3- Trees on the west side of the property.

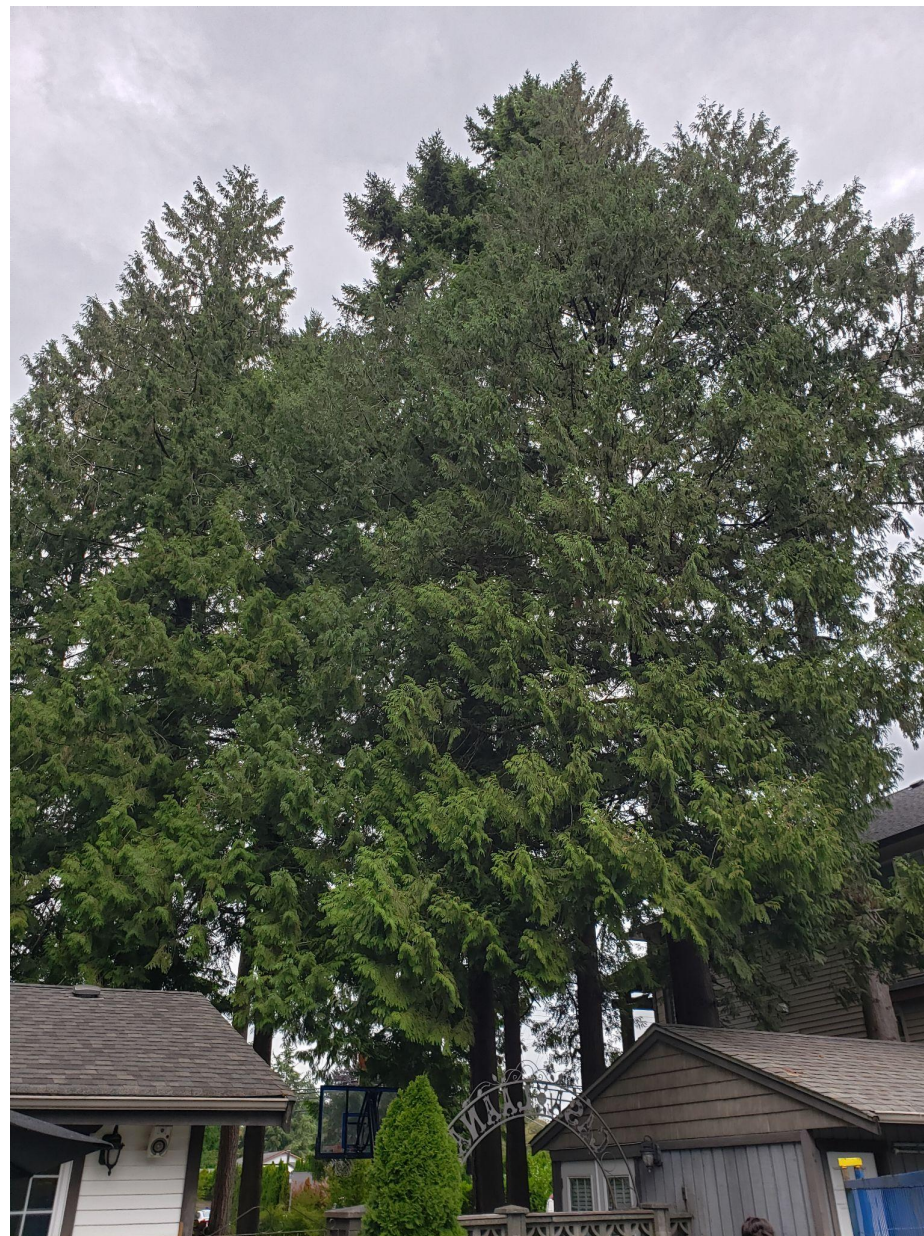
IMAGE 4- Trees on the south west side of the property.
