# 12258 Harris Rd, Pitt Meadows, BC Arborist Report & Tree Protection Plan May 2021

## Arborist Report and Tree Protection Plan

Site Address:	12258 Harris Road, Pitt Meadows, BC V3Y 2E9			
Inspection Date:	February 14 <sup>th</sup> 2019			
Inspecting Arborist:	Craig Southwell (ISA Cert Arb #UI-0484A, Certified Tree Risk Assessor)			
Inspection Brief:	Carry out an inspection of the trees on the property and on neighbouring land close to the boundary. Report on the condition of the trees, their suitability for retention and the measures required to protect any retained trees during the proposed construction activity.			
Background:	The site is occupied by a single commercial building. The proposed development will involve the demolition of the existing structure and the construction of a mixed use structure including parking and landscape. Two small trees are recommended for removal based on their condition and position. A further five trees along the south edge of the site could be retained but may need to be removed if the raised planter in which they are growing is to be removed. Two trees can be retained and will be protected throughout the development of the site.

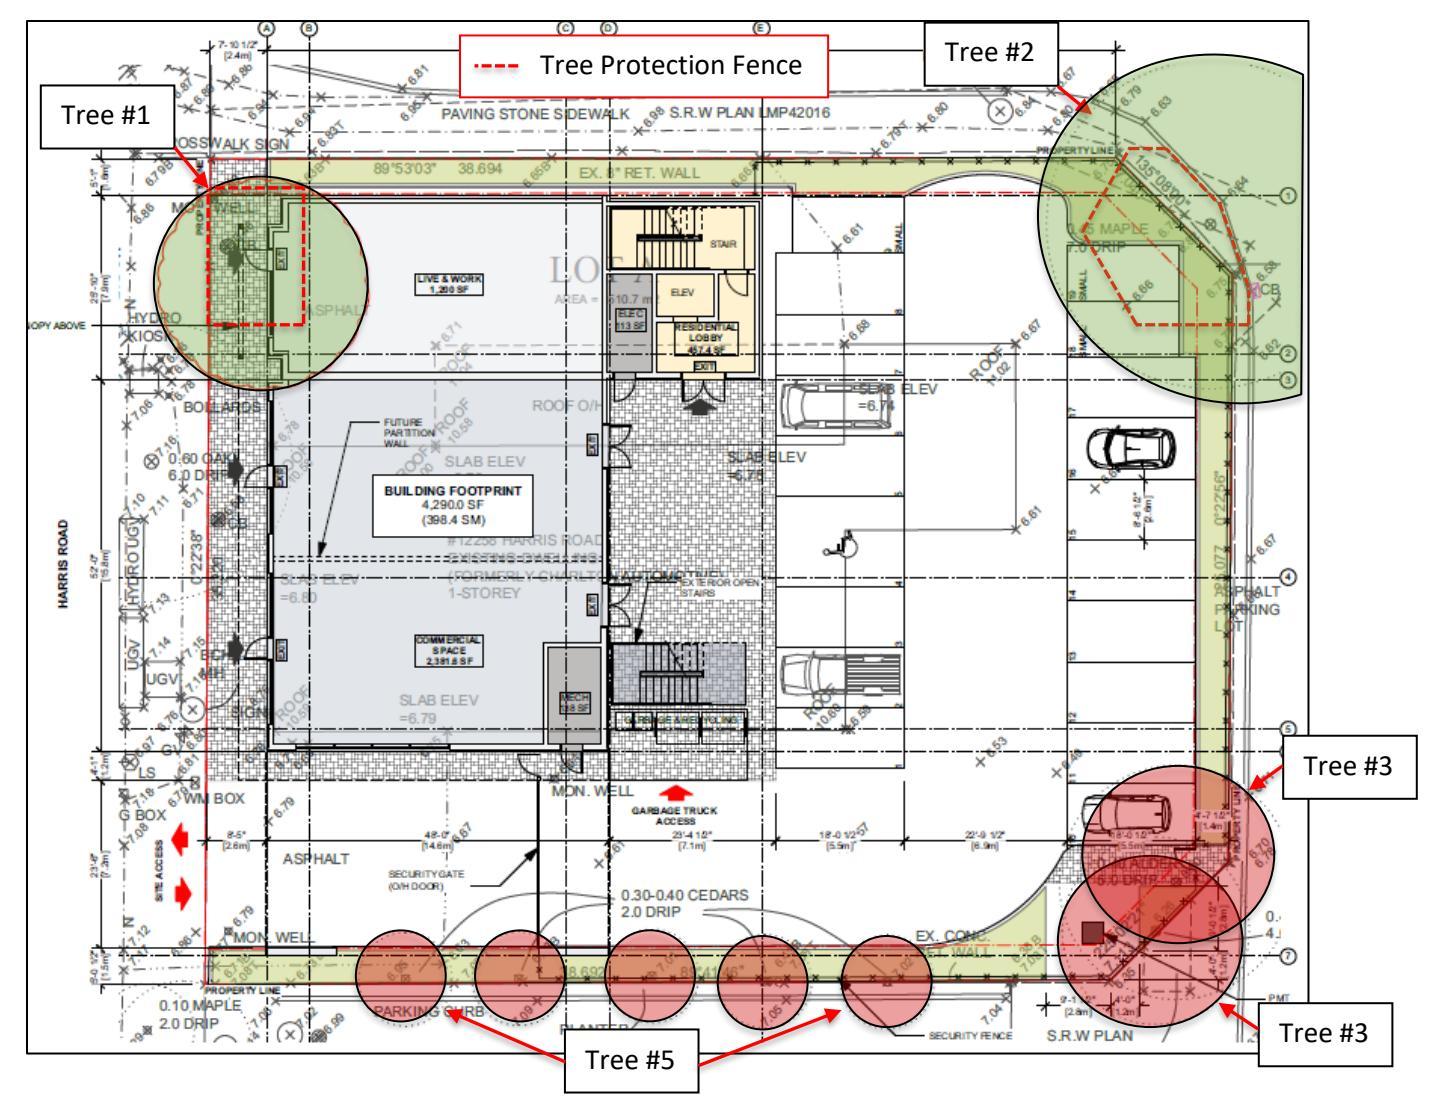
Site Plan showing proposed layout and approximate tree protection fencing.

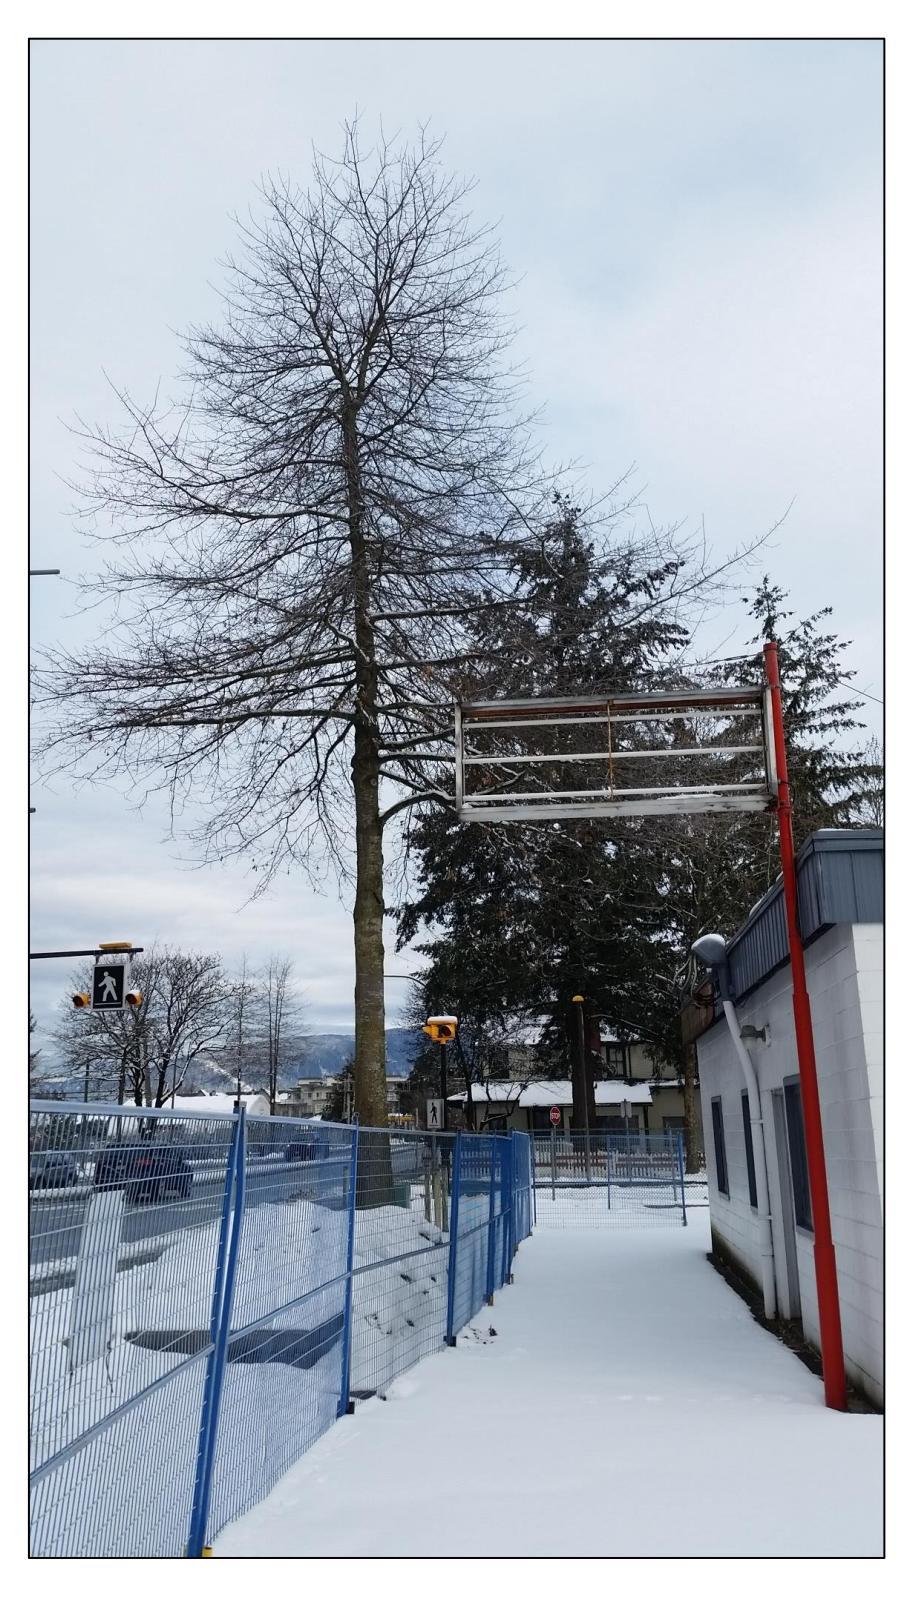
Trees #1 Pin Oak at the front of the property.

- Given the proximity of tree 1 to existing structure, it will not be possible to establish root protection zones to the full extent required. Fences should be installed as close as possible to the structure and may need to be moved during the project, under the supervision of a Certified Arborist. Any work carried out in the tree protection zones must be supervised by a Certified Arborist.

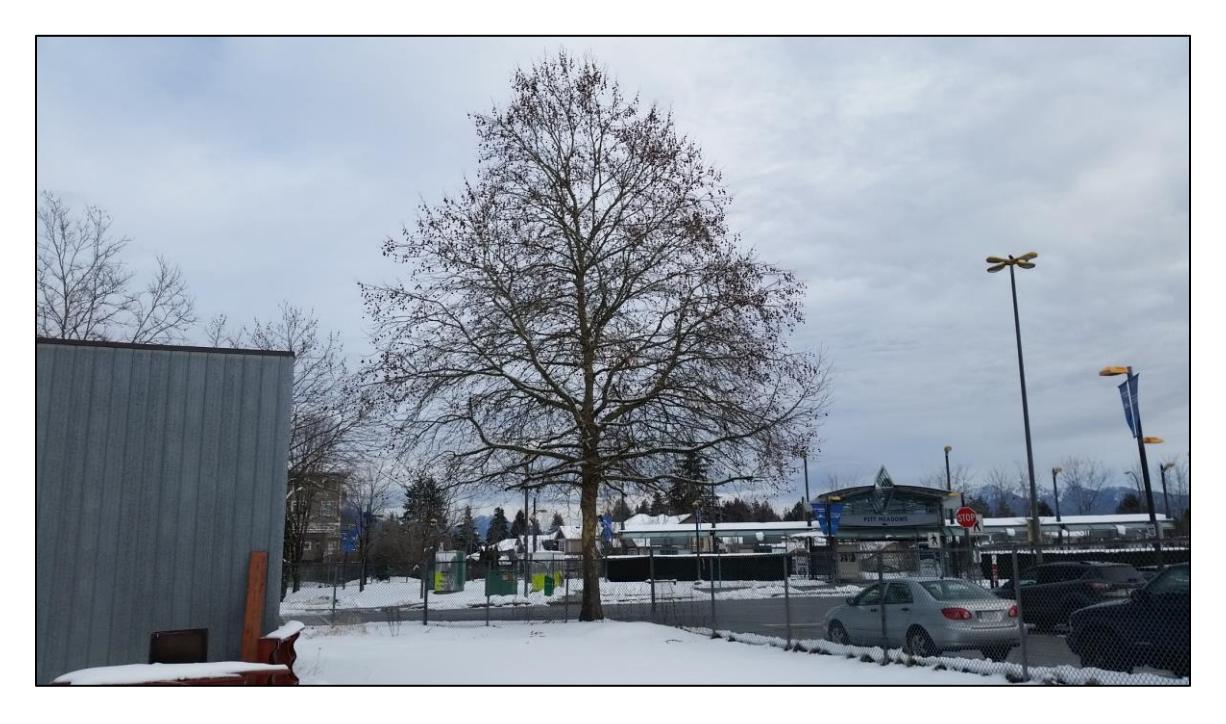
Tree #2 London Plane at the north east corner of the property.

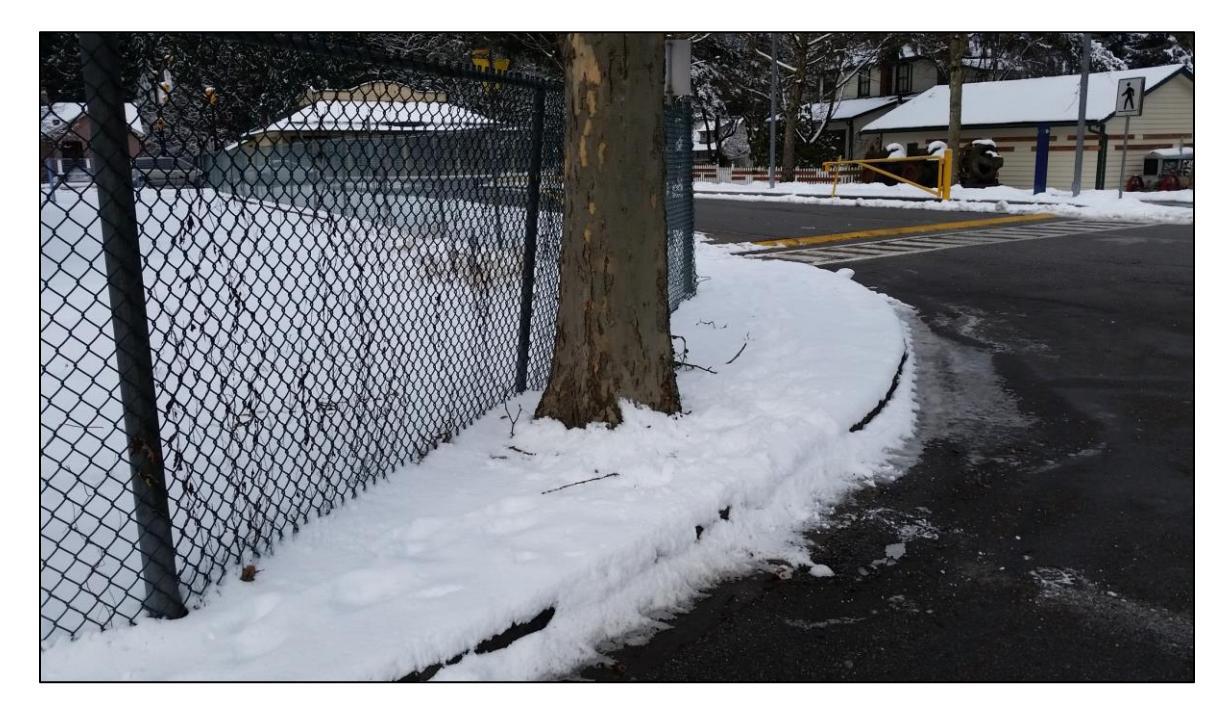
- Trees #1 and #2 will both have construction activity take place within their tree protection zones if they are retained. Tree #2 also has a somewhat limited root zone to the north and east because of the existing road. Before work can commence within the protection zones of these trees, the area should be excavated with an Airspade to ascertain the extent of the roots present. Depending on the extent of root growth in the area to be excavated, it may be possible to retain these trees. However, if significant structural and/or feeder roots are to be lost during the construction they may need to be removed. The construction work within the tree protection zones may result in the decline or instability of the trees.

The base of tree #2 in close proximity the edge of the street.

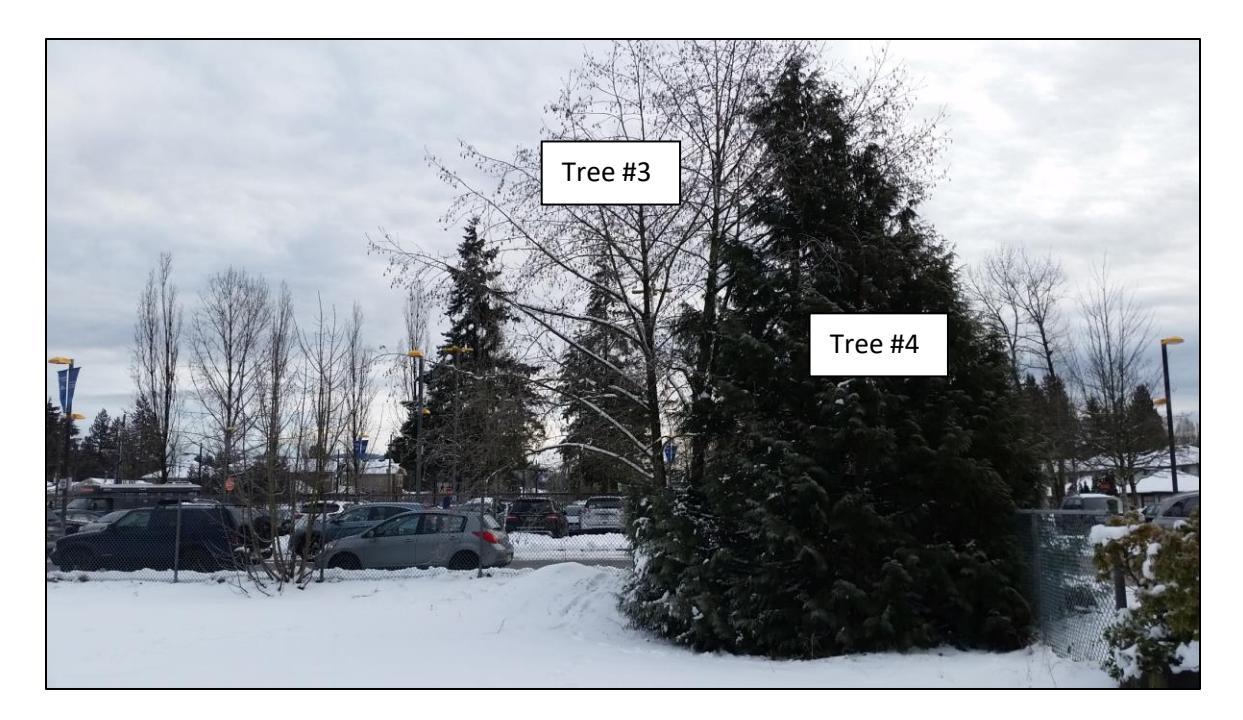
Trees at the south east corner of the site to be removed.

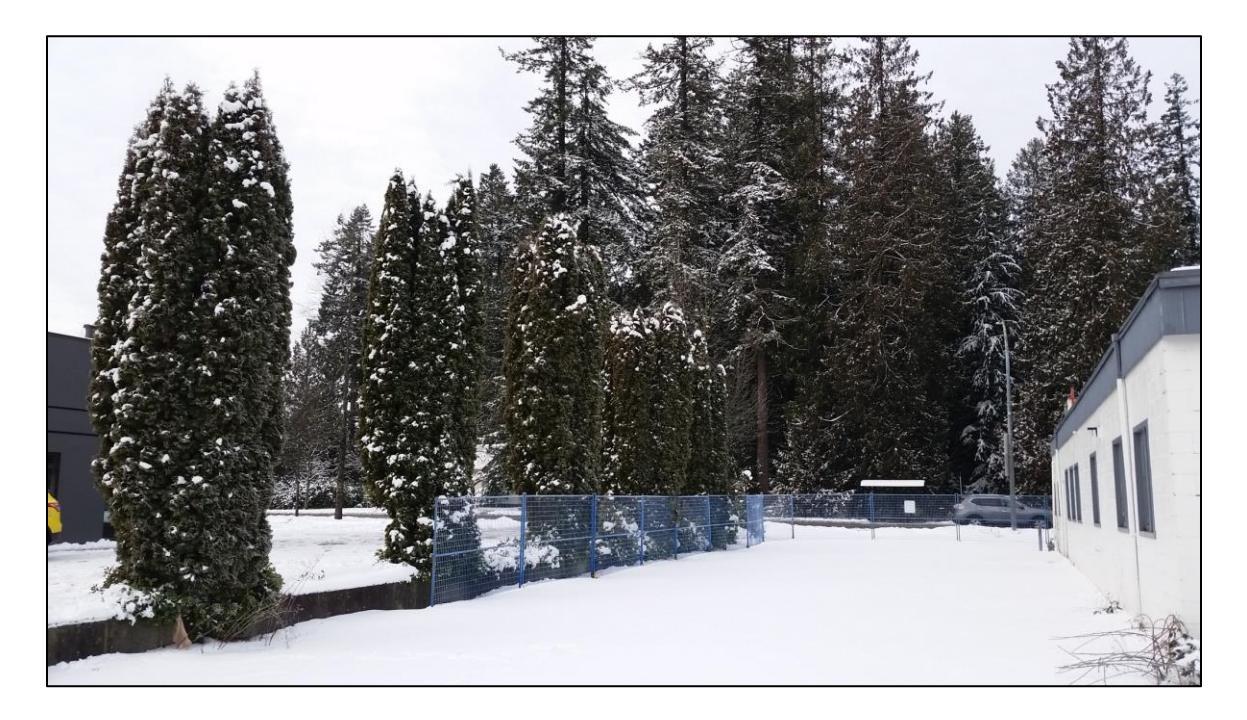
Five Arborvitae Cedars within raised planter on the south side of the site.
