October 14, 2021

Arborist Report

Tree Inventory and Assessment for Development 19560 Hammond Road, Pitt Meadows

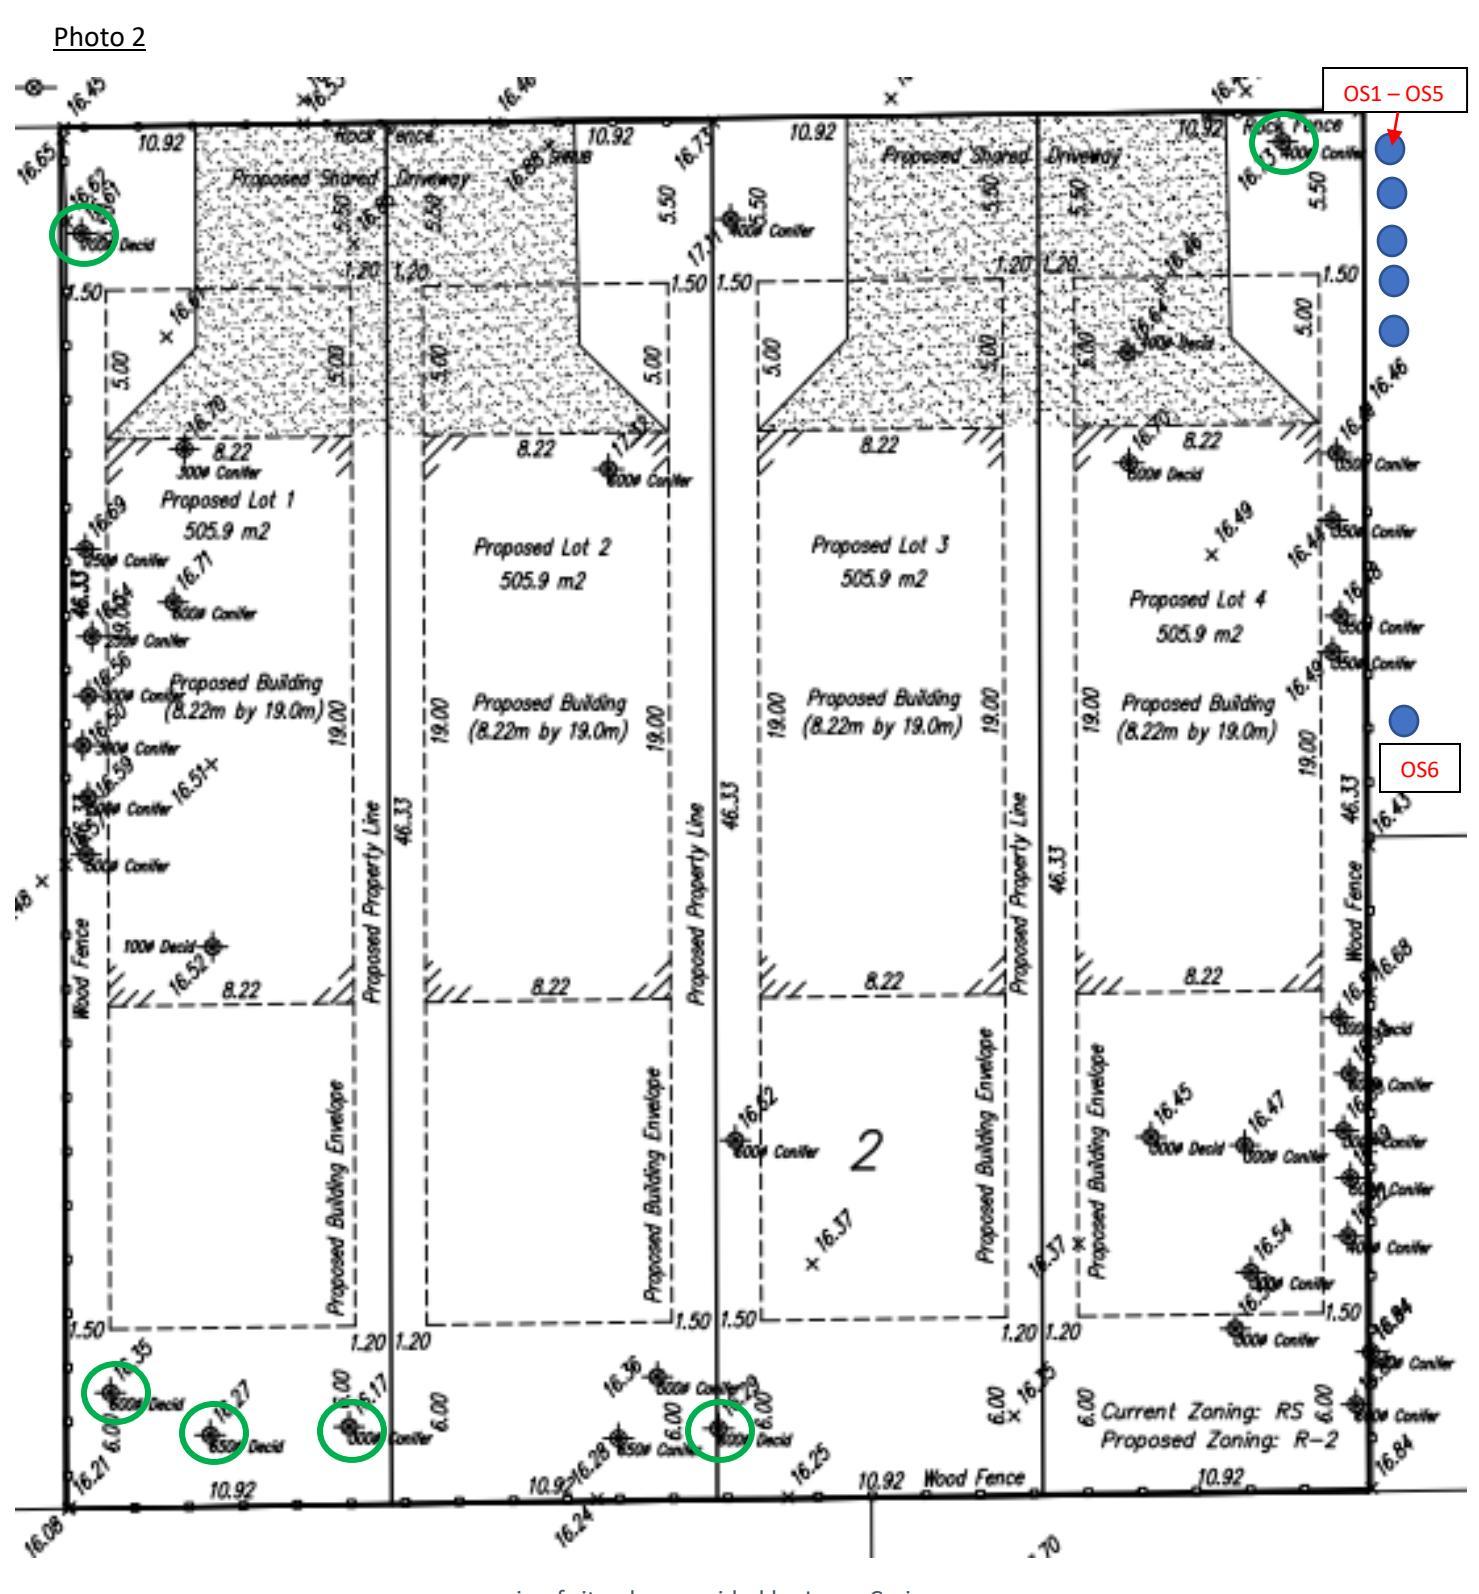
Trees recommended for retention circled

snip of site plan provided by Jason Craig

six trees recommended for retention in green circles; all others to be removed

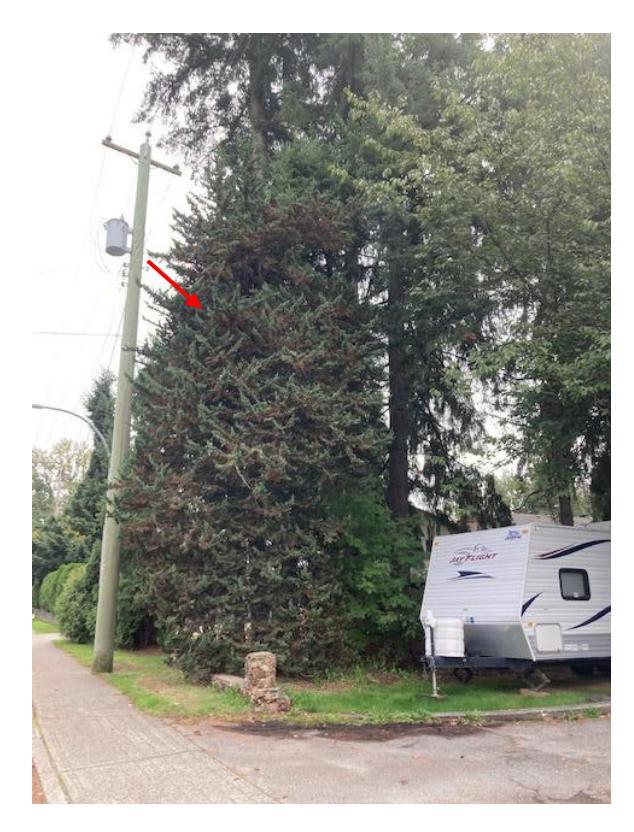
Photo 4: cypress for retention

| Tag # | Species | DBH (cm) | CS (m) | Comments | POF 1-5 | SOP 1-3 | TR 1-4 | Total Risk Rating | Recommendations |
|---|---|---|---|---|---|---|---|---|---|
| 1399 | cypress, | 38 | 2.3 | health fair, structure good - | 1 | 2 | 4 | 7 | retain; deep-root |
| | chumbecypuns sp. | | | drought stress | | | | | 2 3m from trunk |

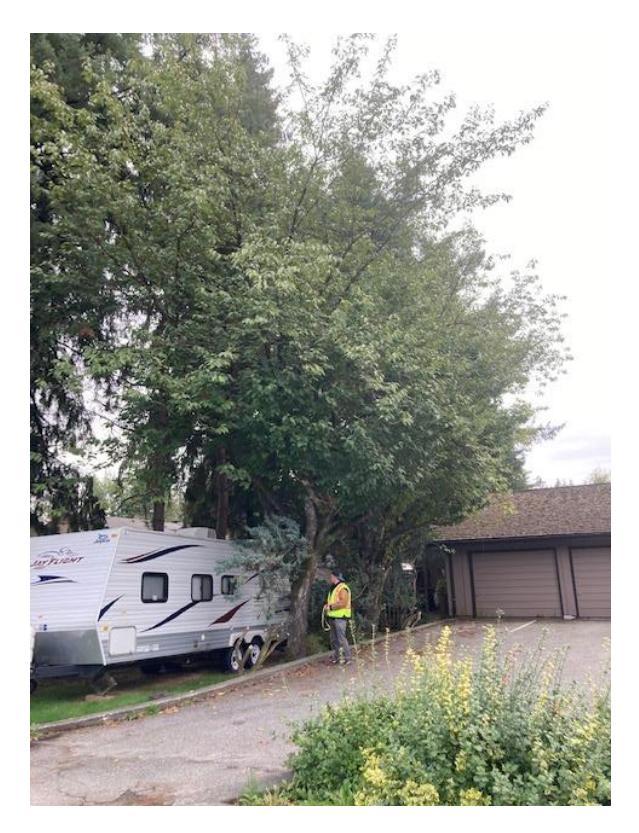
Photo 6: flowering cherries in front

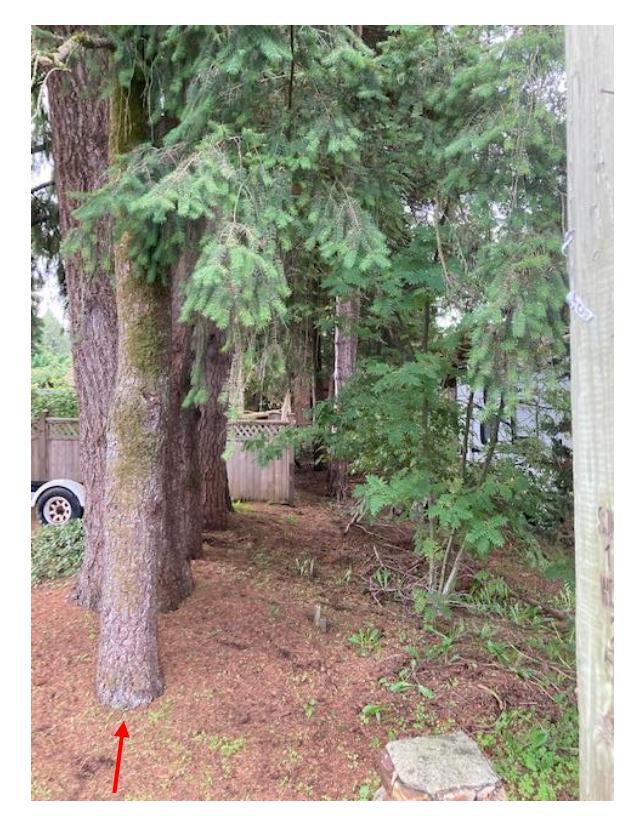
Photo 5: row of firs on neighbouring property

The retained trees on site, and the five neighbouring fir trees, should have tree protection barrier (TPB) installed around them before any other site work begins. Minimum distances for the TPB for these trees are listed in the tree evaluation summary table on pages 9 to 12. Details for adequate construction of the TPB are included below on page 21. There should be no unauthorized activity within these tree protection zones; no excavation, no grade changes and no stockpiling of materials.

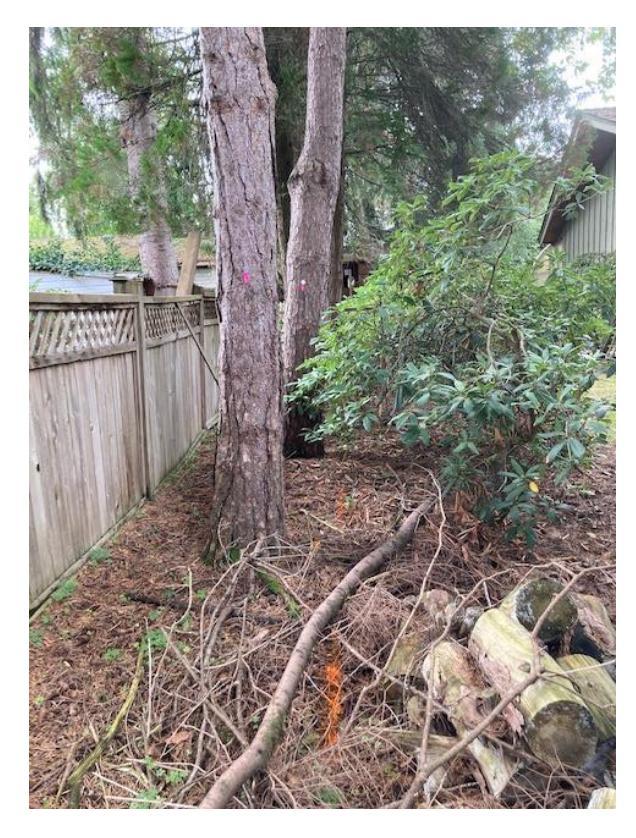
Photo 7: pines at east side; line shows edge of building envelope

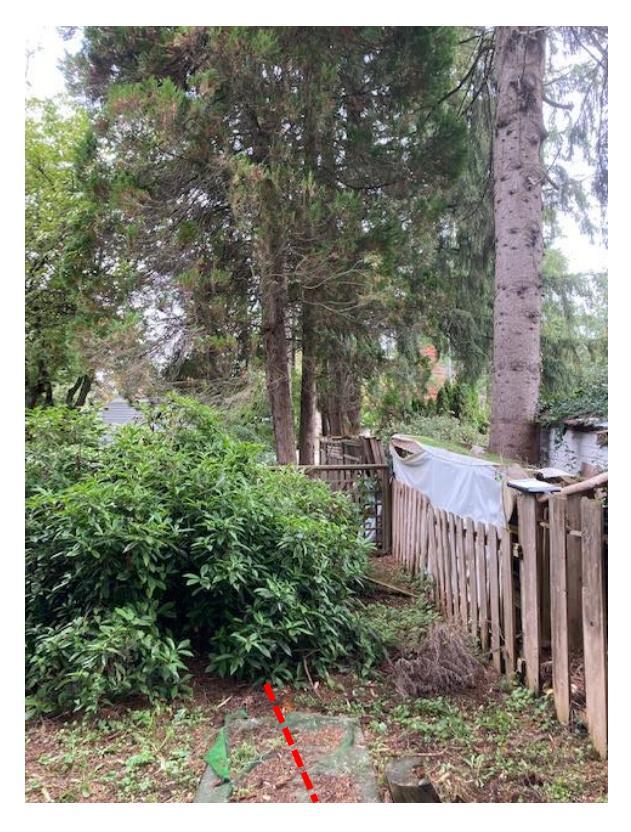
These six large conifers at 19586 Hammond Road could strike the subject property should they happen to fail. The five fir trees (OS1 to OS5) have a low probability of this in my opinion, but the spruce tree (OS6) represents a hazard to the property it is on as well as the subject lot. It has three large tops with a tight angle of attachment; they are competing with each other. There is a high likelihood, in my opinion, of one or more of the tops breaking off and causing injury or damage. A conversation with the owner of this tree should begin without delay, regarding plans to take it down. This tree was assigned a total risk rating of '10' (out of 12 – assessment methods and categories explained below).

Photo 8: spruce, OS6: ~2.5m to 3.0m from bldg. envelope

| Tag # | Species | DBH | CS | Comments | POF | SOP | TR | Total | Recommendations |
|---|--|---|---|--|---|---|---|---|--|
| OS6 | sitka spruce, Picea sitchensis | ~55 | 3.9 | ~1.6m east of property line, in back yard of 19586 Hammond Rd. | 4 | 2 (top) | 4 | 10 | this tree should be REMOVED; this will involve a conversation with its owner |

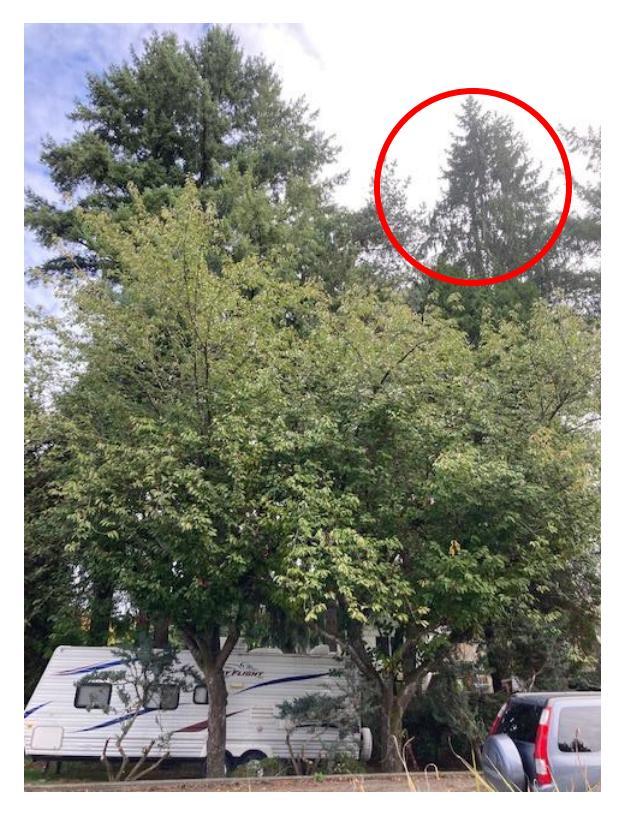
Photo 9: multiple tops in spruce, OS6

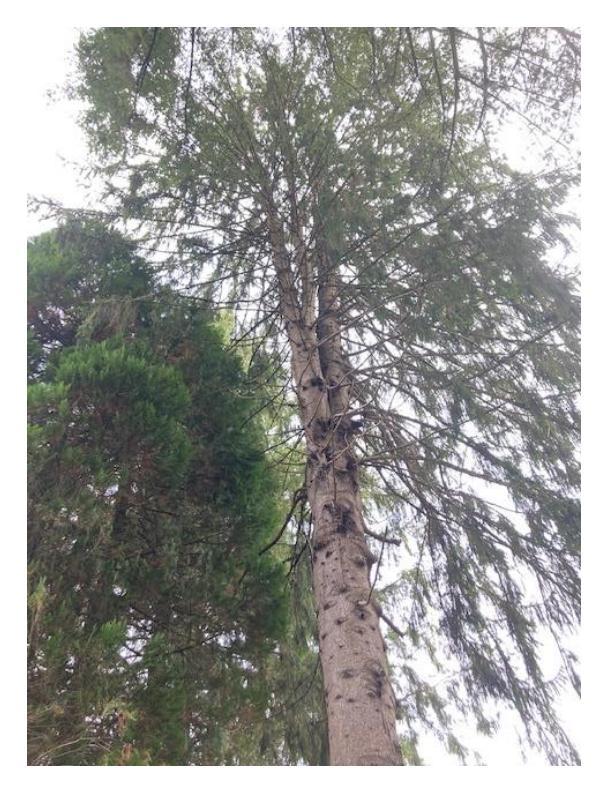
Photo 10: OS6; hazardous tops

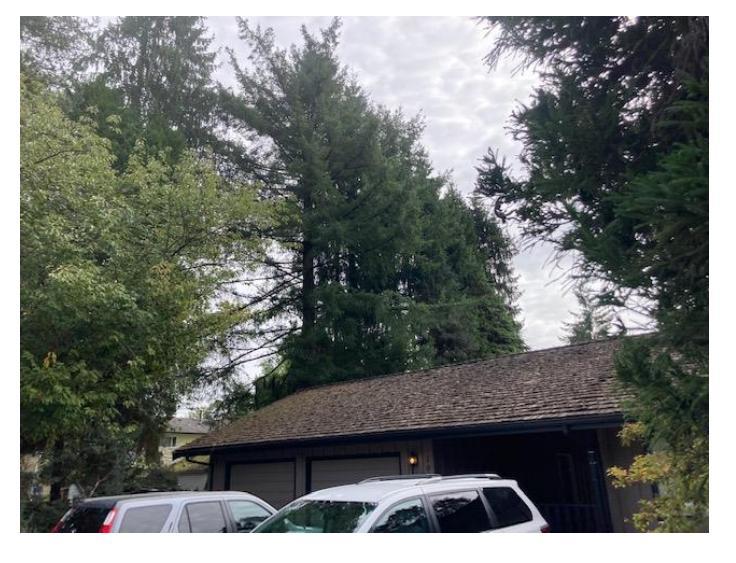
Photo 11: row of evergreens, east side; incompatible

with proposed development

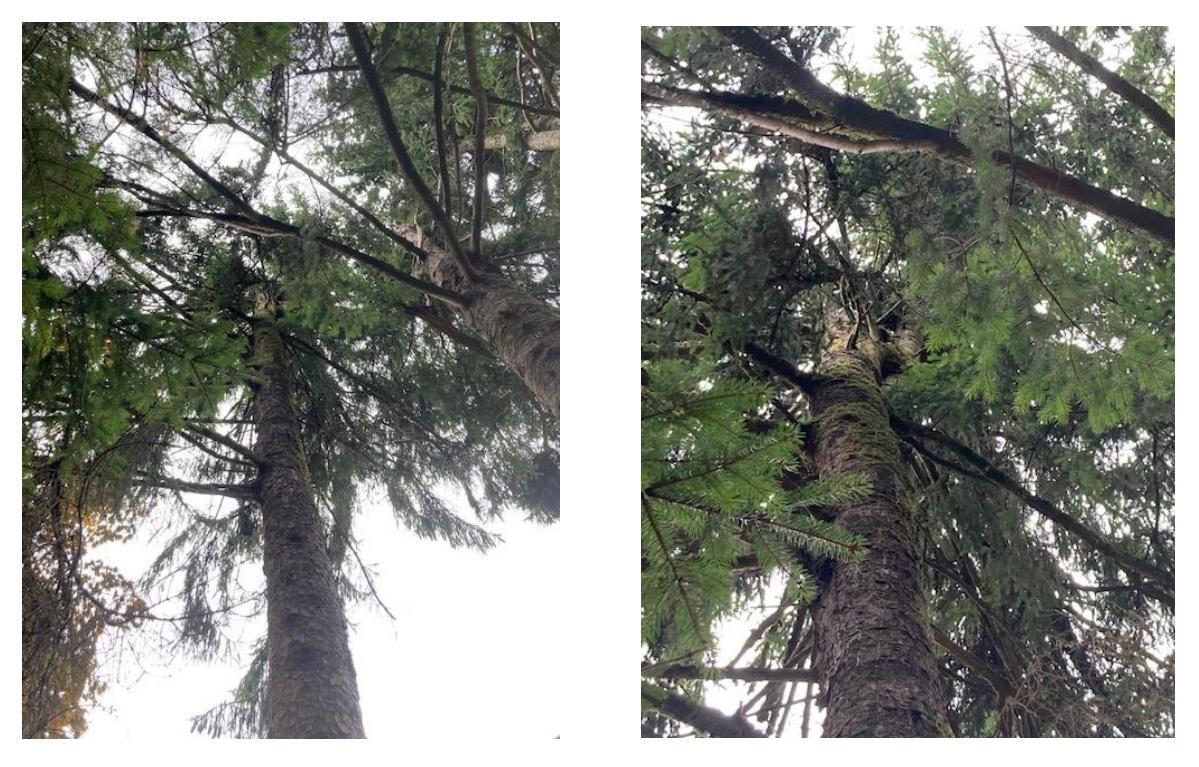
Photos 12 and 13: spruce trees, east side in poor condition; unsuitable for retention

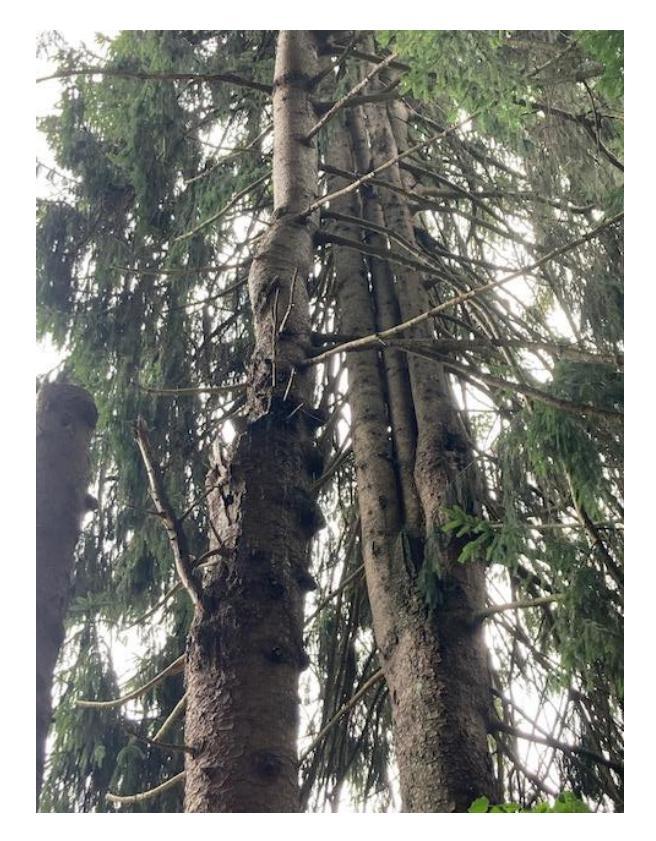
Photo 14: spruce trees in SE corner of lot; hazardous

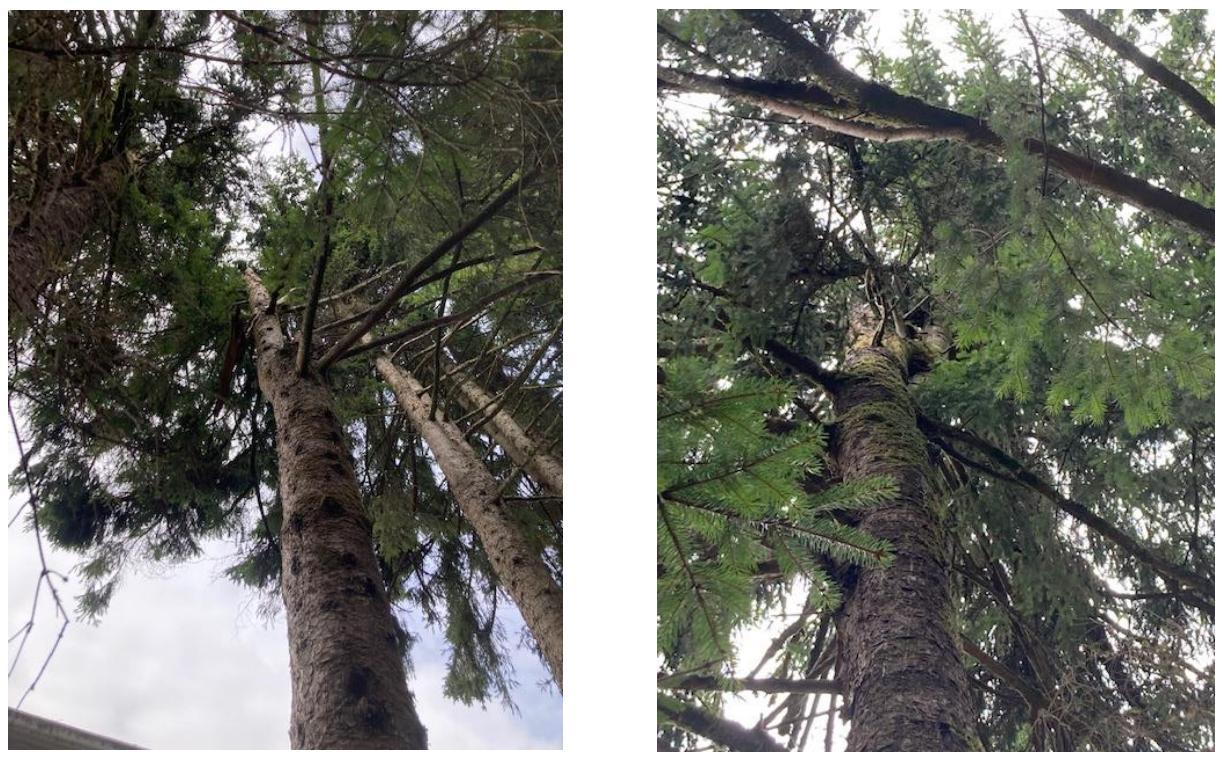
Photos 15, 16, 17: spruce trees along west side; poor condition, unsuitable for retention

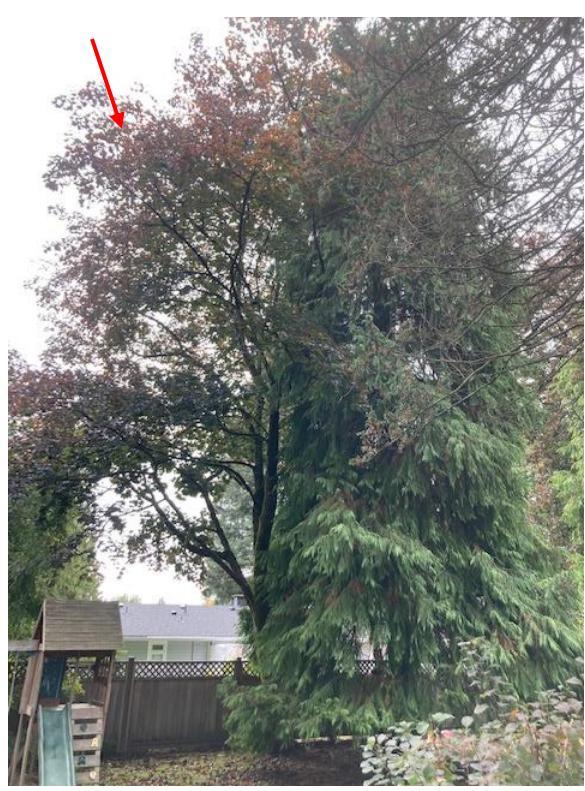
Photo 18: maple for retention, #645

| Tag # | Species | DBH (cm) | CS (m) | Comments | POF 1-5 | SOP 1-3 | TR 1-4 | Total Risk Rating 3-12 | Recommendations |
|---|--|---|---|--|---|---|---|---|---|
| 645 | Crimson King Norway maple, <i>Acer platanoides</i> 'Crimson King' | 45 | 5.8 | health good, structure fair – canopy biased east due to crowding; suitable candidate for retention | 1 | 2 | 4 | 7 | retain; deep-root fertilize; install TPB to 5.8m from trunk |

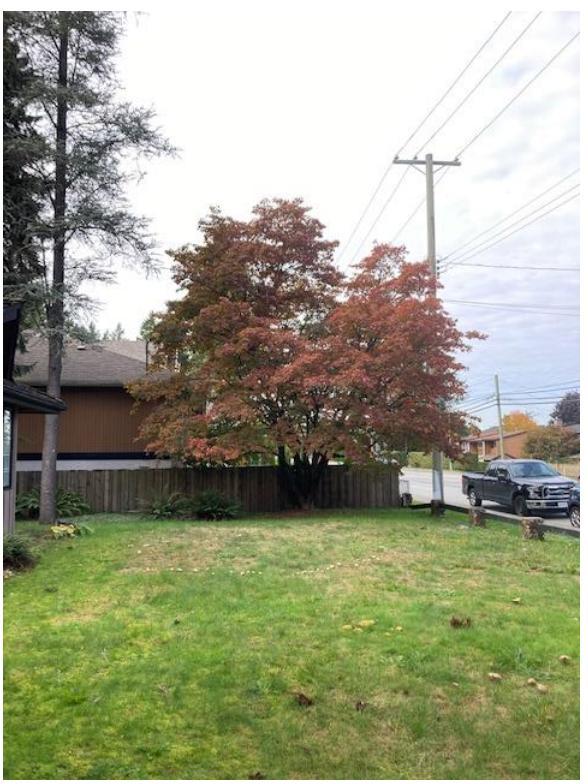
Photo 19: maple for retention, #522

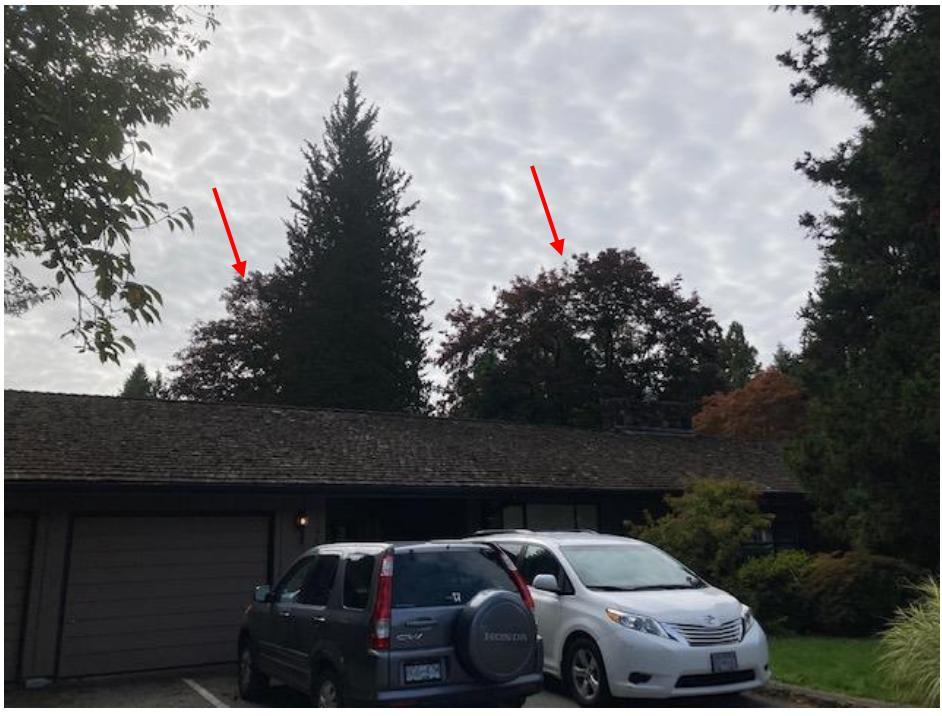
Photo 20: two maples for retention, #649 and #650
