# Staff Report to Council

REPORT DATE: February 19, 2021      MEETING DATE: March 02, 2021  
TO: Mayor and Council  
FROM: Samantha Maki, Director of Engineering & Operations  
SUBJECT: Traffic Operations Safety Review Report – Harris Rd/McMyn Rd and  
Harris Rd/122 Ave

## **PITT MEADOWS – HARRIS ROAD / MCMYN ROAD & HARRIS ROAD / 122 AVE / 122A AVE**

### **Traffic Operations Safety Review**

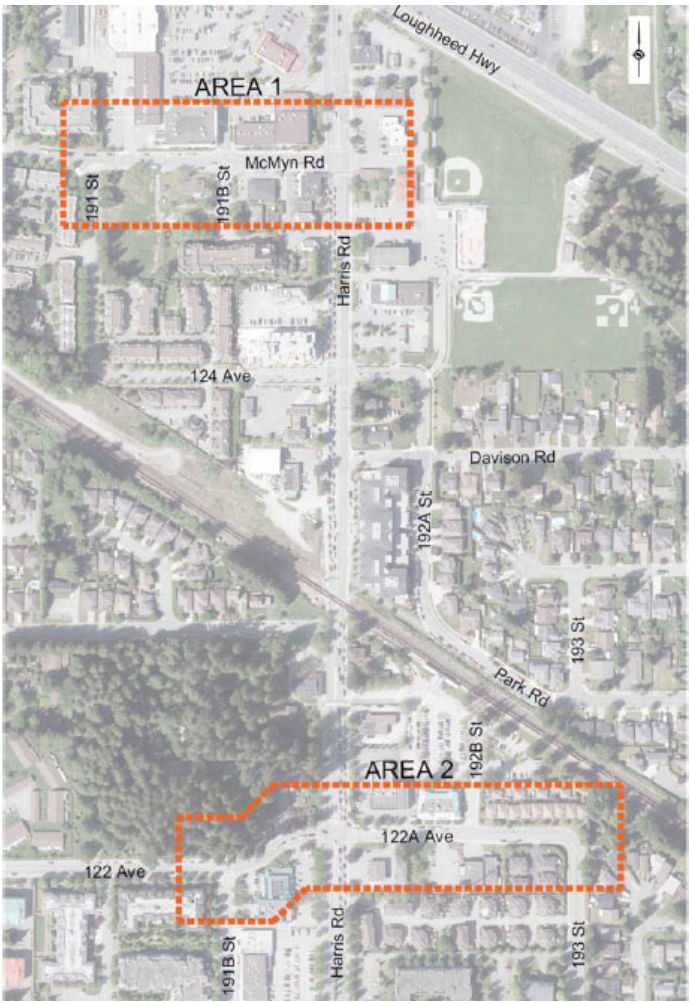
Figure 1 – Study Area Map

in active transportation. The TOSR was coordinated in collaboration with ICBC’s Road Improvement Project. A map of the study area is outlined in the figure below.

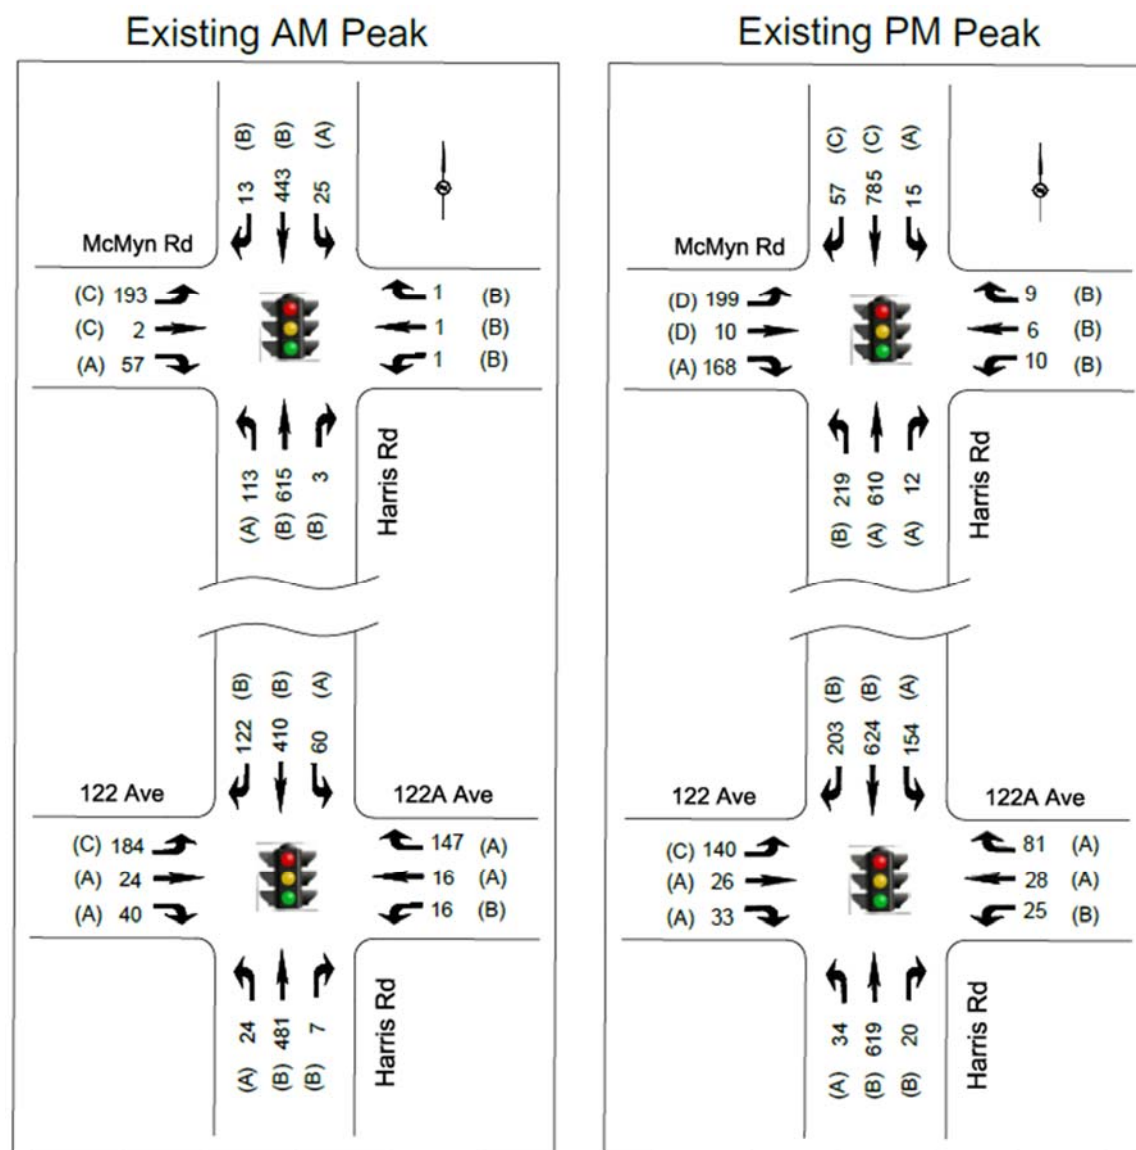
**Figure 3: Peak Hour Traffic Volumes and Level of Service**

Counts for Harris Rd intersections were available from the *Harris Road & Kennedy Road & Rail Data Collection Study (January 2020)*. Traffic volumes for AM and PM peak hours, along with levels of service, are shown in **Figure 3**, for the signalized intersection of Harris Rd / McMyn Road and Harris Road / 122 Avenue / 122A Avenue.

Traffic operations were analysed using Synchro 9 software, for the AM and PM peak hours, to understand operations and potential contributing safety risk factors. Operationally, both

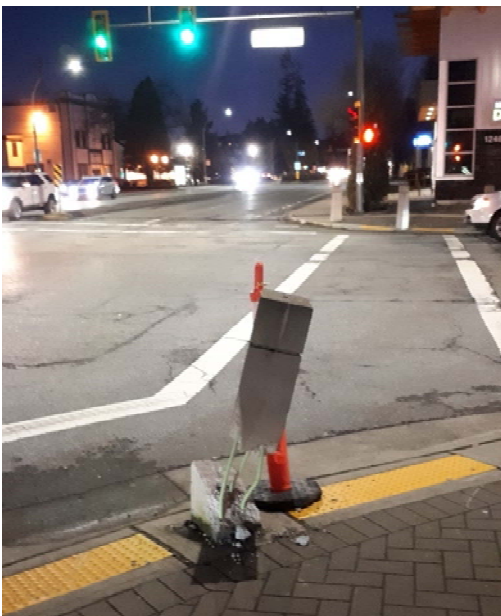
There are concrete bollards located at each corner of the intersection to protect pedestrians. This is a typical standard found in the Subdivision and Development Servicing Bylaw No. 2589, 2013, and are designed with wheelchair ramp. The bollards are intended to protect pedestrians; however, the bollards may provide a collision hazard for trucks with a wide turning radius or motorists who turn too tightly. The bollards are concrete and are therefore capable of causing significant damage in the event of a collision. A damaged bollard was identified on a site visit. Standard sidewalk letdowns should inherently provide sufficient guidance and protection at intersection corners for pedestrians. Alternatively, flexible bollards or bollards with break-away bases could be considered to reduce damage in the event of a collision.

Damaged Bollard (NW Corner)

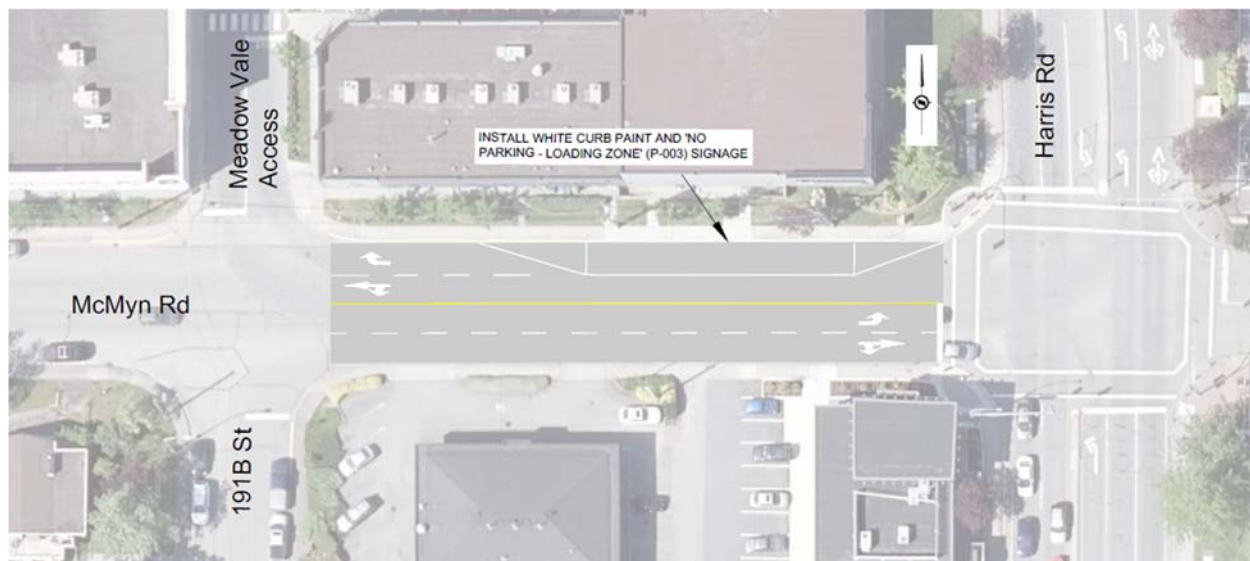
**Figure 7: McMyn Road Re-Laning Concept Sketch**

The roadway width on McMyn Road from curb to curb is approximately 14m, and the lanes are approximately 7m in width. This is enough space for two vehicles to drive abreast of each other. At the intersection, it was observed that westbound vehicles turning into the driveway are not signaling far in advance to provide notice to drivers exiting Meadow Vale Shopping Centre. Pitt Meadows bylaw staff have observed that commercial trucks will often park on the north side of McMyn Road to unload. Given the excess space, pavement marking can be applied to provide a designated loading area, a westbound right turn lane for vehicles turning into the access, and a shared westbound through-left lane. Similarly, there can be a separate eastbound-left turn lane and a shared eastbound through-right lane designated. This will help to meeting driver expectations, because if motorists are not signalling in advance, the lane that they take will reduce the conflict that is created due to drivers expecting motorists to continue straight due to the late signal. Providing the eastbound laning may require restricting parking 10-15m on the south side of McMyn Road east of the intersection. See **Figure 7** for a concept sketch.

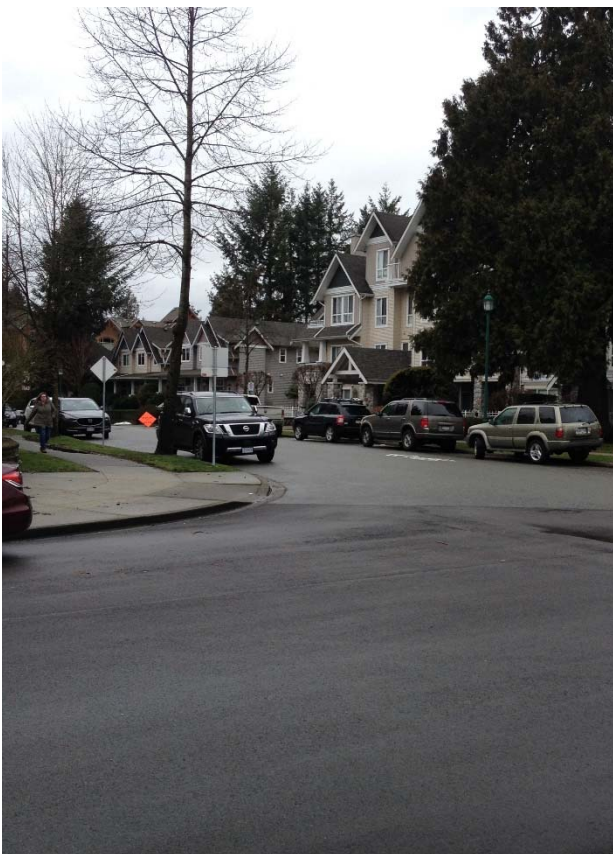
The southeast intersection corner is set further south than the southwest intersection corner. Sightlines from 191 Street looking northwest are partially obstructed by parked vehicles on the south side of McMyn Road. Parking restrictions on the south side of McMyn Road west of 191 Street could be implemented to improve sightlines. TAC recommends a sightline of 95m to the left; however, in order to provide the recommended sight distance, parking would need to be restricted along the south side of McMyn which would result in a loss of approximately 10 on-street parking spaces. Alternatively, installation of a curb extension on the southeast corner would allow the stop sign and stop bar to be moved ahead to improve the sightlines without requiring restricted parking.

191 Street looking North West

- Install a curb extension on the southeast corner and move the stop sign / stop bar ahead to improve sightlines.
- Re-instate the stop bar on 191 Street unless City policy states otherwise.

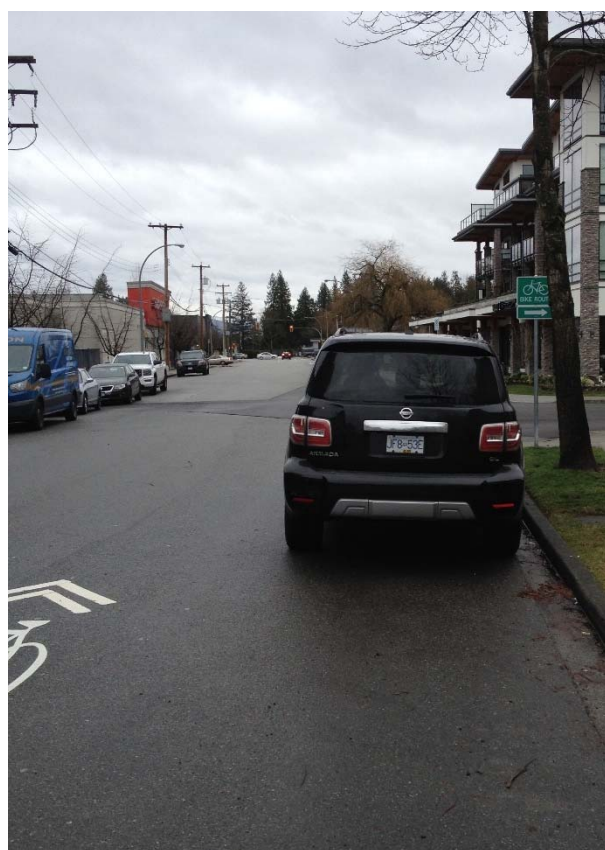
The stop bar for the south approach on 191 Street is currently missing but is present in 2018 ortho-photos; the stop bar should be re-instated unless there is a pavement marking policy that the City has indicating otherwise. It is assumed that the stop bar was removed during construction of the development on the south-east corner of the intersection and will be re-installed pavement repair after construction.

McMyn Road looking East

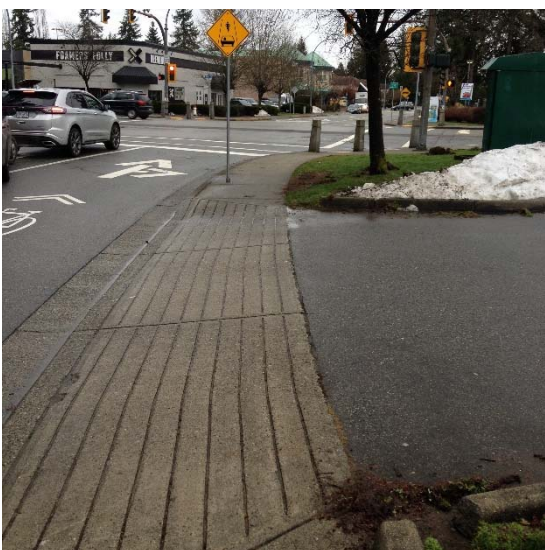
The access to the Chevron on the south approach is also located within 15m of the intersection. The configuration of the access has been a contributing factor to one left-turn collision with northbound traffic along Harris Road. This access should be restricted to right-in right-out traffic only.

East approach, close proximity to driveway

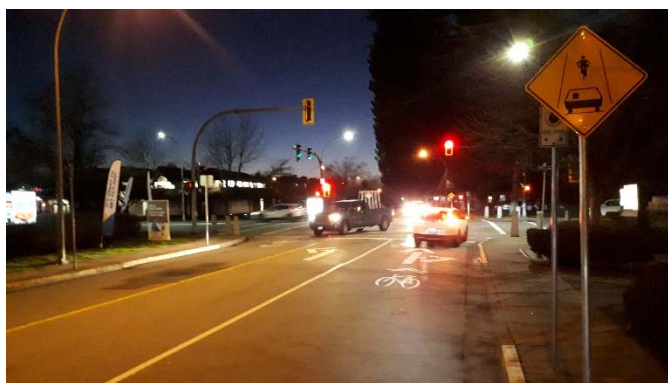
- Left turn tapers – deficient for the northbound/southbound left turn lane (20/19m) vs desirable minimum of 24m (at 8:1 ratio).
- Curve on west approach – “S” curve located on west approach may restrict sightlines to crosswalk
- Driveway spacing – there are driveways near the intersection.

West Approach

- Clear foliage where possible to improve sightlines.
- Move the crosswalk to the west side of the intersection and install curb extensions on the north side of the intersection which tie into the “s” curve.
  - May require moving the existing bus stop to the east.

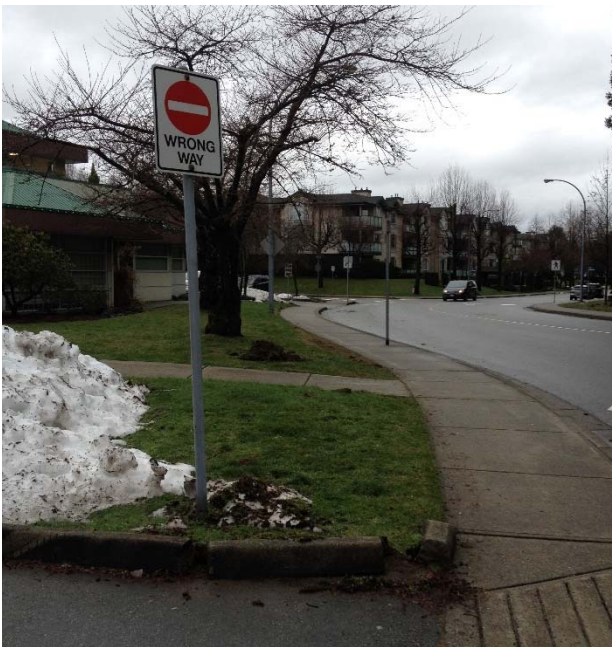
122 Avenue looking towards 191B Street

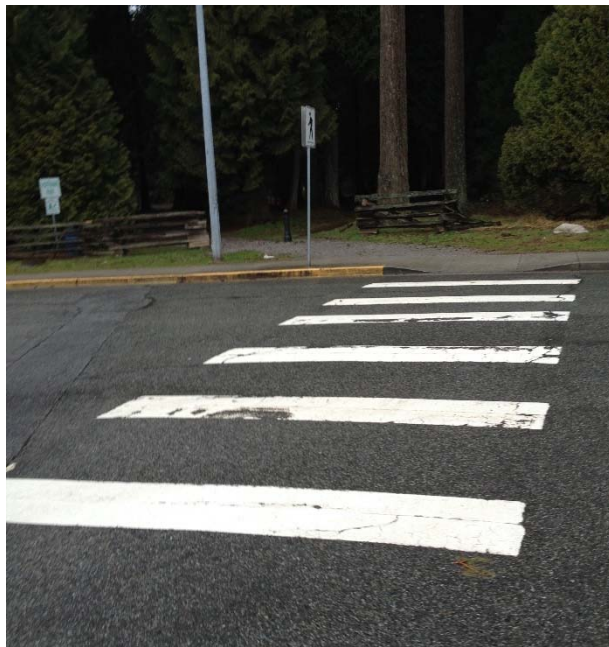
East Crosswalk

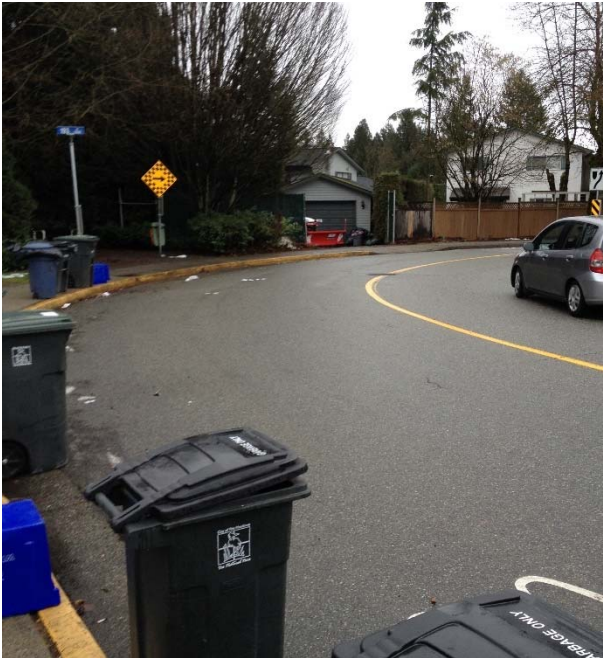
The curve was measured to have a radius of 15m. According to TAC, this corresponds to a design speed of 20km/h and is appropriately marked by the warning signage placed in advance of the curve. Motorists were observed to drive over the centerline, indicating that they may be driving at higher speeds than the 20km/h advised.

122A Avenue looking South East

- Provide a curb extension in advance of the parking west of 193<sup>rd</sup> Avenue to provide protection from westbound traffic.

- A cost-effective treatment could be placing delineators to form a curb extension. The delineators also have retroreflective material which may help to improve visibility.
- Consider installing traffic calming devices (speed humps, tables or cushions) on the approach to the curve.

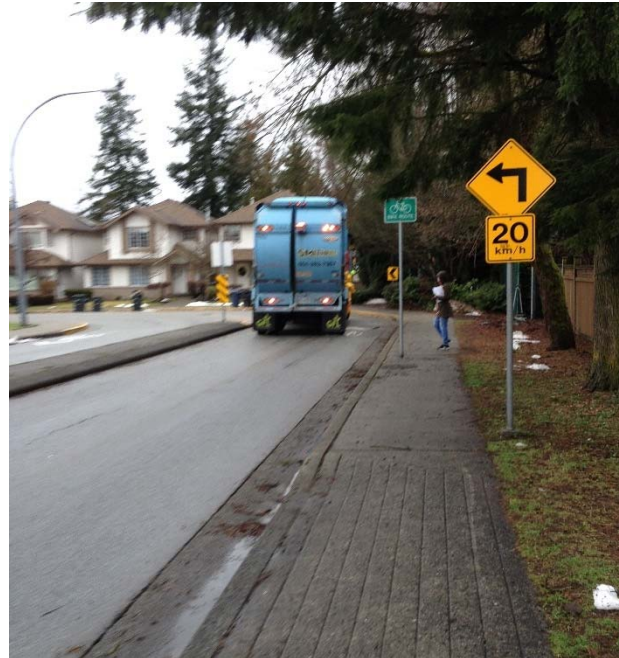
193 Street looking North West

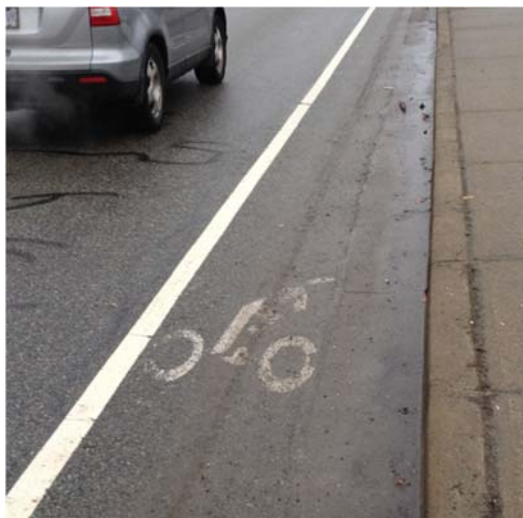
South of McMyn Road, Harris Road has very narrow bike lanes that vary between 1.0 to 1.1.m including the gutter pan. This is lower than the minimum recommended width of 1.2m, and preferred minimum of 1.5m as identified by TAC. There are also no bike lane signs and the

markings are inconsistent with current Canadian practice (as well as faded in many areas). The narrow lanes are a particular concern as they may give cyclists the false sense of security of sufficient space, but also give motorists the message that cyclists should ride in that area and not encroach the motorist lane (which cyclists may be compelled to do, given the lack of space and the presence of the gutter pan which serves to push cyclists further out).

Although the bike lanes end at McMyn Road, there is no 'Bike Lane Ends' sign warning northbound cyclists that the lane will end, and the lane line remains solid until the intersection (as opposed to a broken line to indicate the end of the bike lane). Cyclists north of McMyn Road are either forced to take the road, or ride on the sidewalk if they are not comfortable.
